# UXO 18 PROPOSED REMEDIAL ACTION PLAN PUBLIC MEETING & RESTORATION ADVISORY BOARD (RAB) MEETING NUMBER 50

6:00 p.m. - 8:30 p.m. | August 2, 2016 | Punta Mulas Lighthouse, Vieques

Proposed Remedial Action
UXO 18, Cayo La Chiva
Former Vieques Naval Training Range
Vieques, Puerto Rico

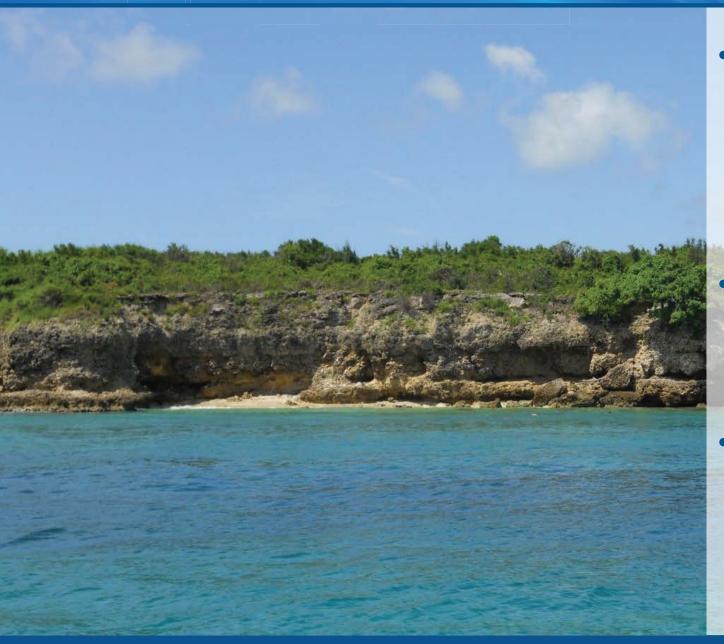
## Cayo La Chiva Features

- Cayo La Chiva is 12
   acres, located
   several hundred
   yards offshore of
   Playa La Chiva (Blue
   Beach)
- Island is rocky, densely vegetated, and has steep cliffs on most sides
- Access to the island is limited to northern tip of island where a narrow sandy beach is present

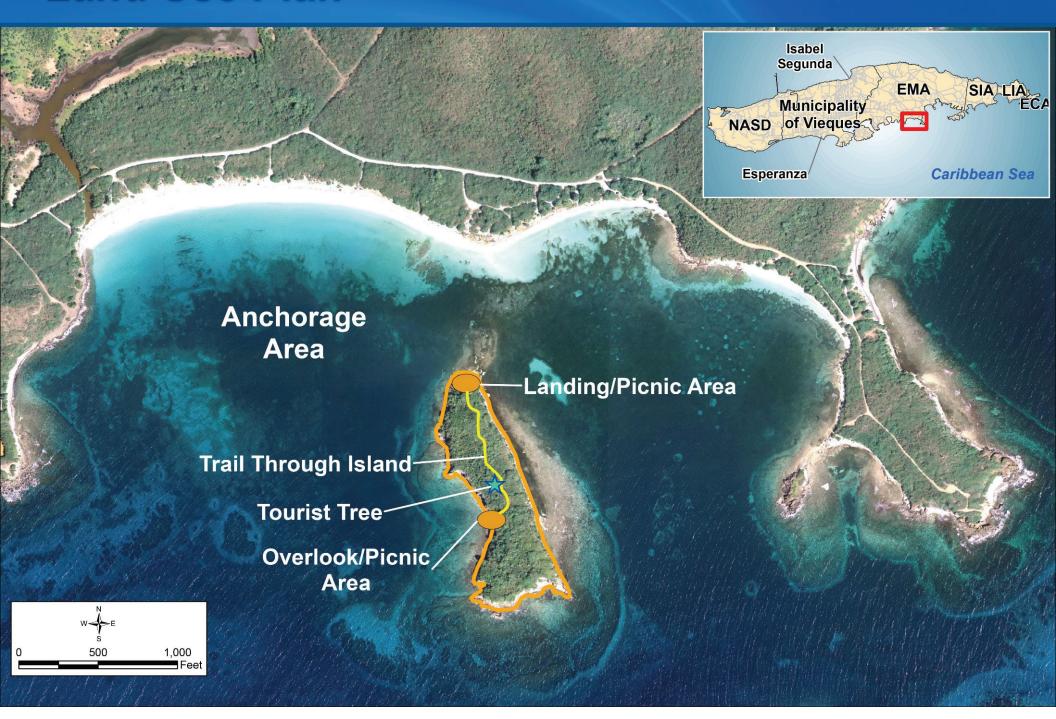
### **Land Use Plan**

- Owned by the Commonwealth of Puerto Rico
- To be managed as a recreational area by Puerto Rico Department of Natural and Environmental Resources (PRDNER)
- Planned features include:
  - Beach use
  - Picnic areas
  - Interpretive trail
  - Observation tower

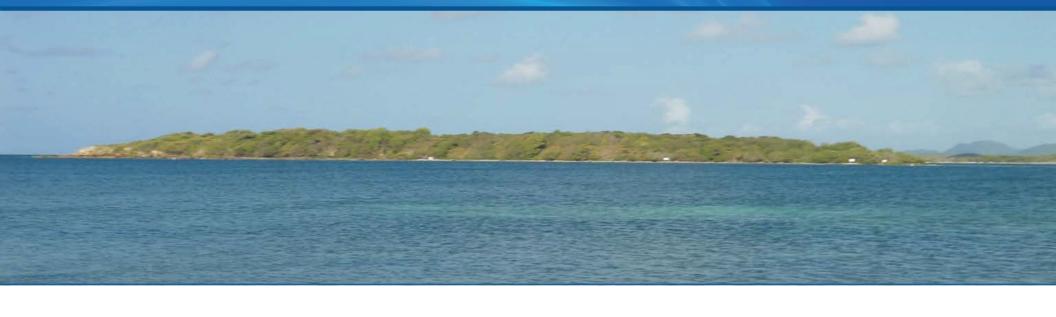
### **Historical Use**

### Limited military training activity

- Records indicate a 0.50-caliber machine gun was located on the island that fired blank rounds during amphibious landings at Playa La Chiva
- Field observations identified five 5-inch rockets and three smoke canisters

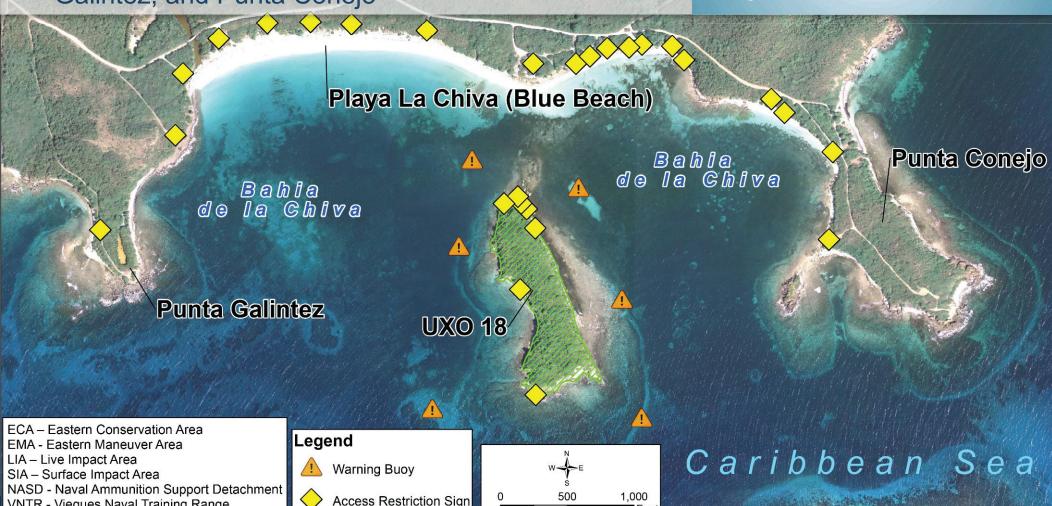
#### Warning Buoy and Sign Installation (2012)

7 warning signs installed on Cayo La Chiva

- 6 warning buoys installed around Cayo La Chiva
- 20 warning signs installed at Playa La Chiva, Punta Galintez, and Punta Conejo

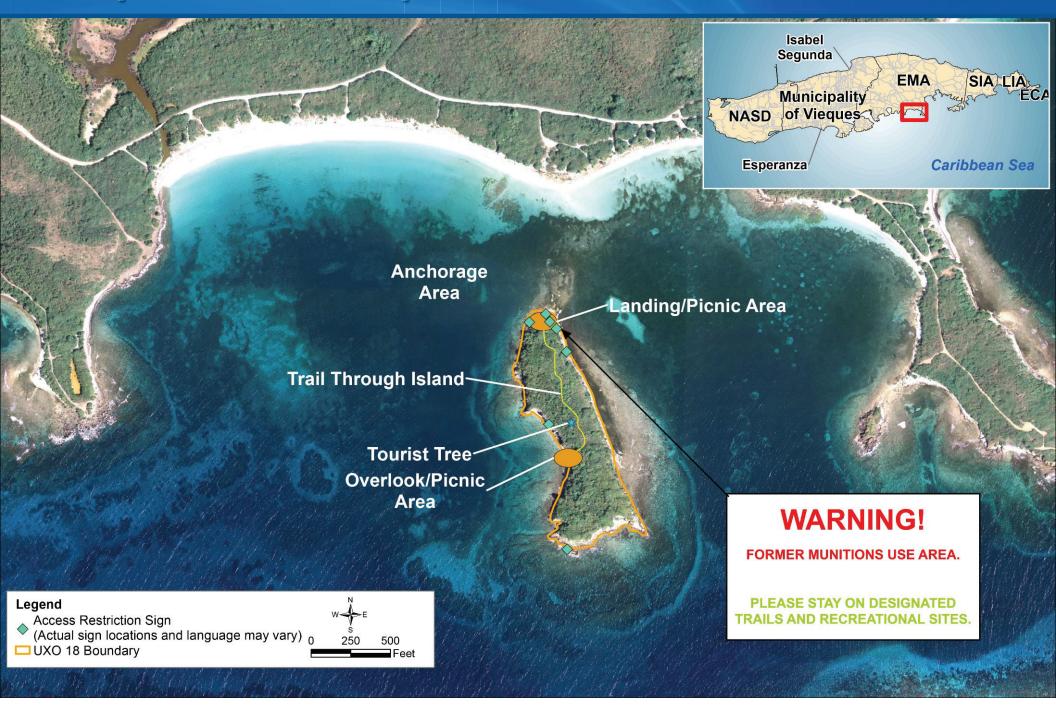
## **Proposed Cleanup – Alternative 3**

- Alternative 3 Focused Munitions Removal, Land Use Controls, and Inspections
- Why Alternative 3 is the preferred cleanup:
  - Vegetation and munitions clearance is focused in areas identified by PRDNER for recreational use
  - Island-wide vegetation and ecological habitat are preserved
  - Land Use Controls and routine inspections will continue to ensure reduced explosive hazard
- Navy, EPA, PREQB, and PRDNER agree on the proposed cleanup alternative
